ENGINE MANUFACTURER'S FACTUAL REPORT

ANC08FA053

Operator: ERA Helicopters LLC
Location: Chickaloon, Alaska
Date: 15 April 2008
Time: 0930 Alaska daylight time
Aircraft: Eurocopter AS350B2 S/N 3158
Registration: N213EH
Engine: Arriel 1D1: S/N 9641
Module 1 - Accessory Gearbox S/N 9646
Module 2 - Axial Compressor S/N 2998
Module 3 - Gas Generator S/N 9211
Module 4 - Power Turbine S/N 9996
Module 5 - Reduction Gearbox S/N 9731

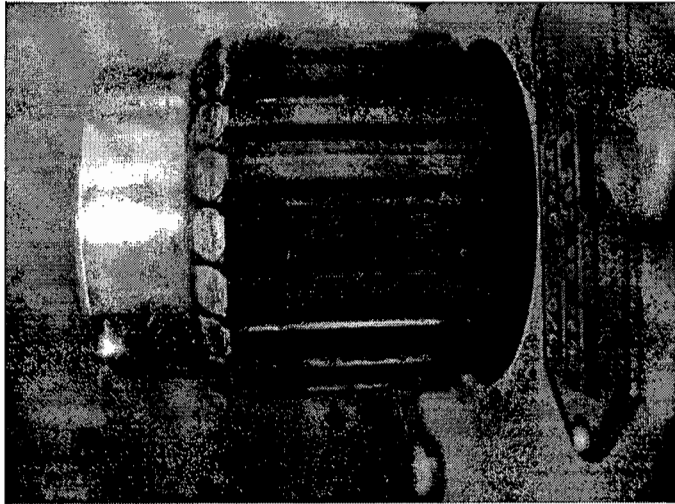
An arrival inspection and engine component inventory was conducted in the presence of the NTSB IIC and representatives from the BEA and FAA. The engine front mount was intact with no visible damage. The linking tube was dented (approximately four o'clock position) at the rear mounting point. The splined shaft of the free wheel shaft exhibited rotational damage at the forward edge of

Figure 2: Splined Shaft - damage

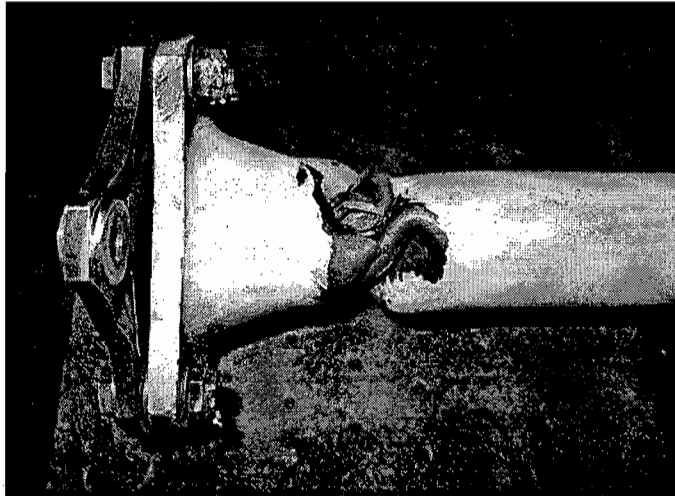
The engine disassembly revealed that an over torque event occurred, leading to shortening and disconnection of the engine to main gear box transmission shaft. This disconnection (on the engine side) was followed by an over speed of the free turbine that resulted in the designed shedding of the power turbine blades. The damages found on the engine are the consequence of the blade shedding. The internal damage to the engine is consistent with the engine continuing to run after the free turbine blade shedding. Disassembly of the free wheel assembly revealed slight marks on two rollers and on the inner race. These marks are not sufficient to explain a possible "sliding / re-engaging" of the clutch. The findings on the FCU test bench inspection were normal for a FCU experiencing 2,316 hours of operation since overhaul. There were no indications of abnormal fuel flow or FCU response.

Figure 4: Shaft – damage

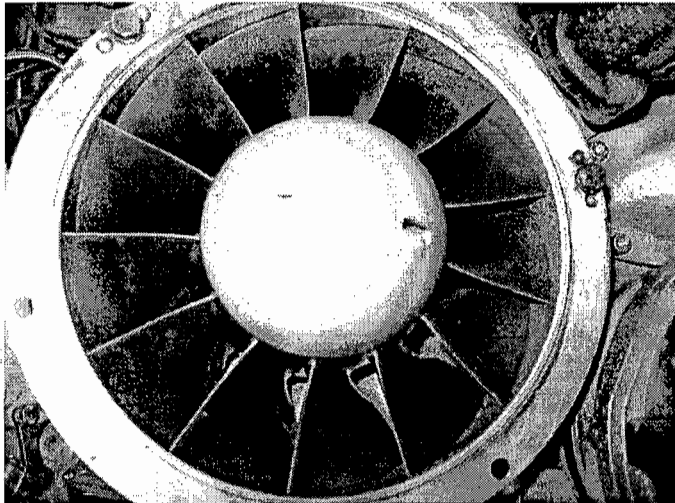
the splines (the connection to the aircraft transmission shaft). The engine bleed valve was in the open position. The inlet nose cone was intact with no visible damage. Foreign object damage (small nicks) was found on all blades of the axial compressor. Corresponding rub marks were observed on the compressor casing. The axial compressor blade erosion check was 1.5mm. The gas generator was seized. The free turbine had experienced blade shedding. Dents were observed inside the exhaust duct. Free turbine rotation was confirmed, but was difficult due to the damage. The bearing support assembly was twisted and buckled. The containment ring was intact. Two bolts (left side) of the four bolts that attach the MO2 to MO1 were sheared at the MO1 helicoils. The MO2/MO3 had shifted outboard and upward and the 'O ring' at the accessory drive pinion was visible. The accessory drive pinion housing on the MO2 casing was elongated. All engine pipes and hoses (air, fuel, and oil) were secure. No indications of leaks were observed. The engine oil filter by-pass button indicated there had been no by-pass. The electrical magnetic plug at the oil outlet was clean, a small sliver was observed on the electrical magnetic plug of the rear bearing oil return. Both MO1 and MO5 magnetic plugs were contaminated. The oil filter was clean. An oil sample was collected from the MO5 oil sump. Visual external inspection of the fuel control unit (FCU) revealed no anomalies. The FCU was removed from the Accessory Gear Box (MO1), sent to the fuel component department, and installed on the FCU test bench.

Figure 6: Axial compressor – FOD

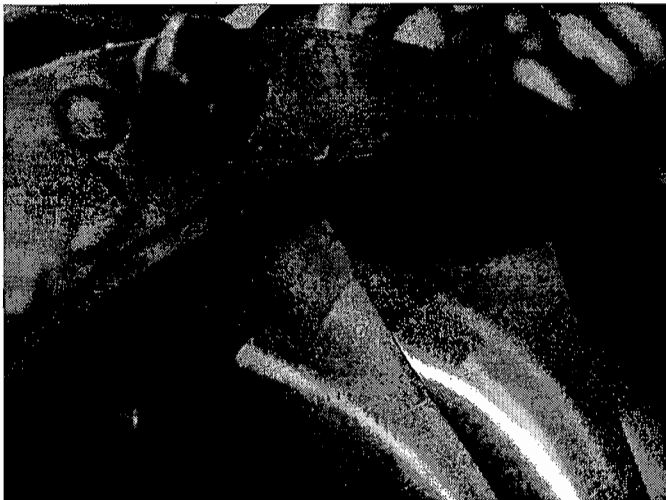
Figure 7: Axial compressor – FOD

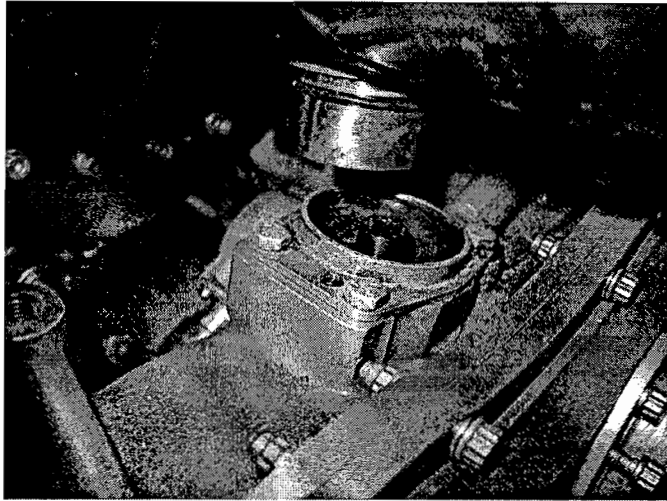
Figure 8: MO2 – twisted and separation from MO1

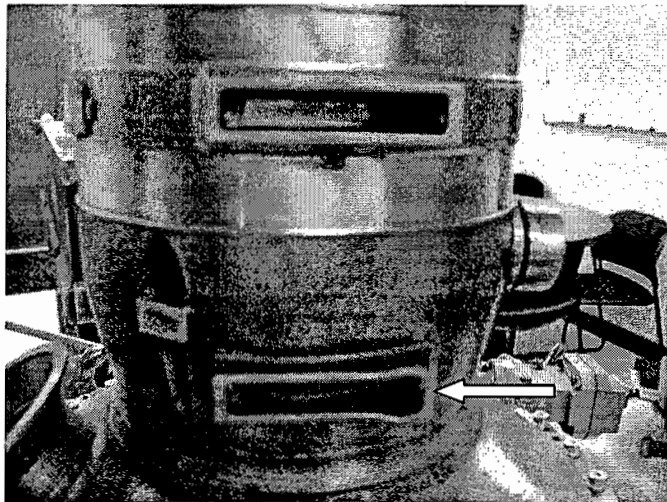
Figure 9: Compressor case – damage

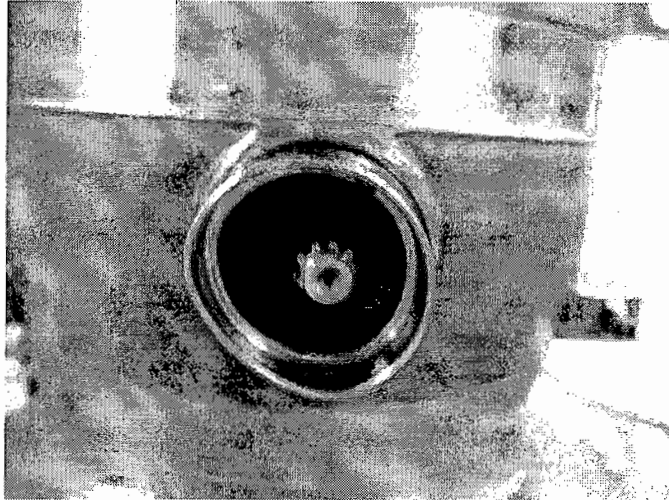
Figure 10: Drive pinion housing – elongated

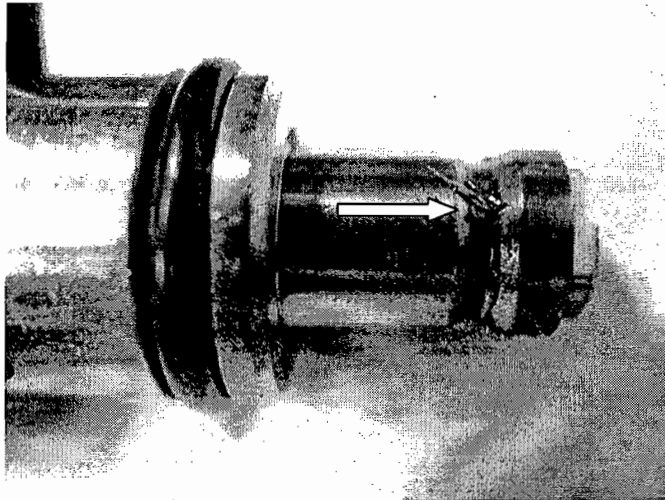
Figure 13: Electrical magnetic plug – sliver of metal

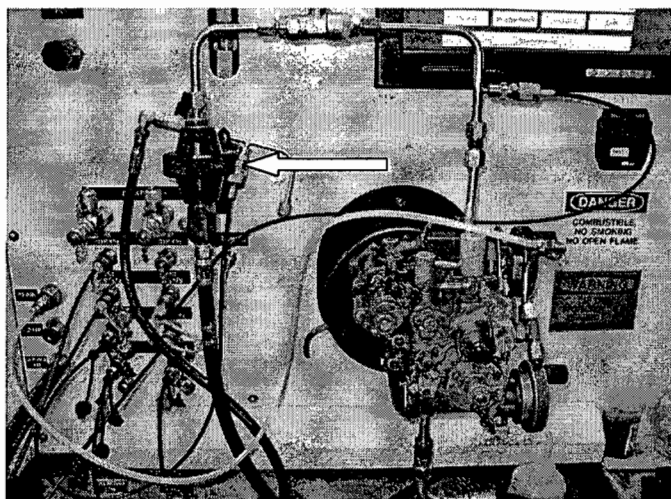
According to the FCU log card, the FCU had operated for 2,316 hours since the last overhaul in January 2005. During those 2,316 hours of operation, no discrepancies were reported. The 13 factory-installed tamper-proof lock wire seals were intact. The anticipator coupling and main fuel coupling were rotated through their full range of travel; no discrepancies were noted. The FCU fuel filter was removed and inspected, no anomalies noted. For the test, a new 63 micron 'in line' filter element was installed on the bench. When the FCU was started, a fuel leak was observed at the cap plug of the strainer. The strainer is located on the right side of the intermediate body. It was decided to perform the test without repairing the leak. The FCU was tested in accordance with the functional test procedures and applicable Arriel 1 Engine Repair Manual. The test findings were normal for an FCU in service. There was no indication of abnormal fuel flow or FCU response. The 'in line' filter element was removed after the test; no contamination was noted. Disassembly of the FCU was not required.

Figure 14: FCU on test bench - 63 micron filter

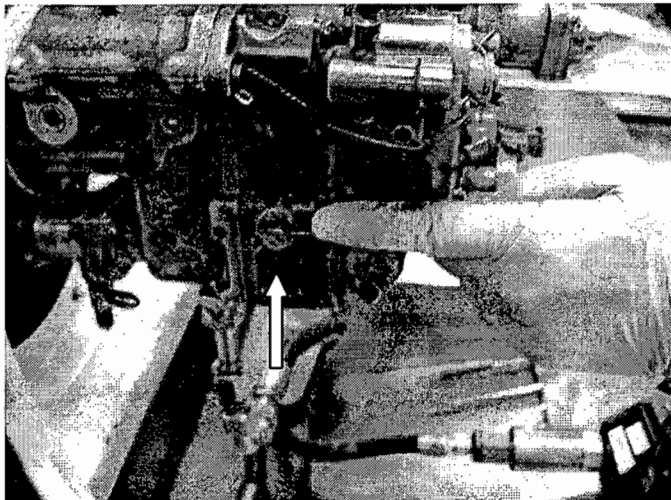
Figure 15: Cap plug – leaking

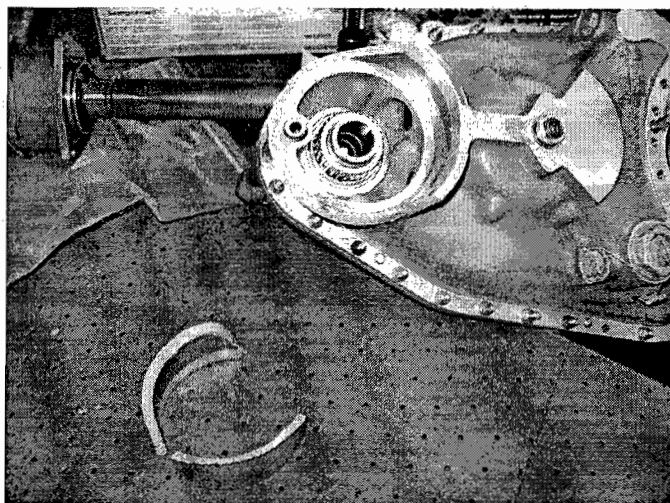
The disassembly examination consisted of the removal of the Reduction Gearbox (MO5), removal of the Free Turbine (MO4), and removal and disassembly of the Free Wheel assembly. Removal of the MO5 revealed the top of the module casing had cracked and two pieces of the casing had separated. The muff coupling between MO4 and MO5 was correctly installed according to the inscribed marks. The coupling exhibited flaring and rotational damage at both forward and aft splines. The degree of damage was greater at the forward splines (MO4 side). The index marks on the MO5 input drive gear and lock nut were misaligned in the tightening direction. The misalignment measured 7mm. Rotational continuity of the MO5 gear train was confirmed, rotation was smooth with no binding. Due to the damaged bearing support, removal of MO4 required the use of a plasma torch. The containment ring was intact and had contained the blade shedding. All the turbine blades had separated from the turbine disc at the designed shear point. The power turbine shaft was intact. When the disc was rotated by hand, a scraping noise was noted. The bearing assembly was not disassembled. Removal of the free turbine nozzle guide vane revealed carbonization in the engine rear bearing assembly. The rear bearing was rotated by hand. The labyrinth air seals exhibited rotational damage. Rub marks at the second stage turbine blade path were observed. The free wheel shaft assembly was removed from the engine and disassembled. The splined shaft exhibited rotational damage at the forward edge of the splines (the connection to the aircraft transmission shaft). The free wheel shaft was bent. No dimensional examination was performed. Disassembly of the clutch housing revealed marks on two rollers of the clutch. One mark was observed on the inner race. To repackage the engine for storage, it was necessary to separate the MO2/MO3 from the MO1. When separated rotation of the compressors and gas generator turbines was confirmed, but was difficult with a scraping noise. Rotational continuity of the MO1 gear train was confirmed, rotation was smooth with no binding.

Figure 16: Reduction Gearbox – case damage

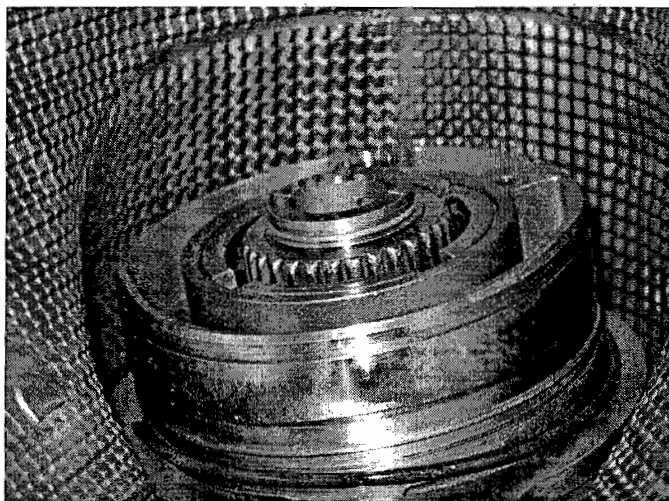
Figure 17: MO5 drive gear – spline damage

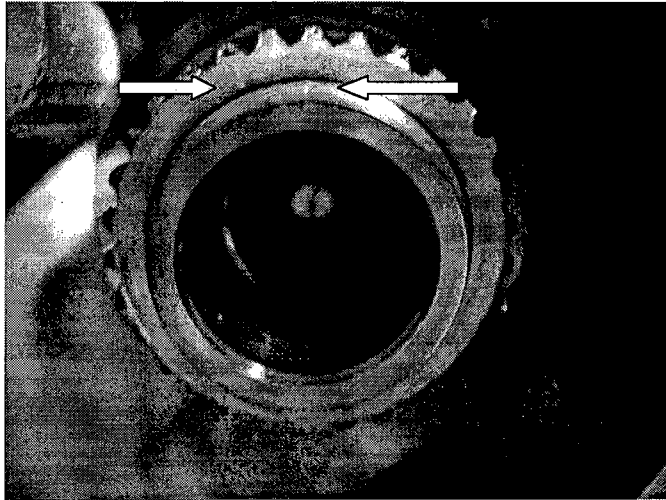
Figure 18: MO5 drive gear - misalignment 7mm

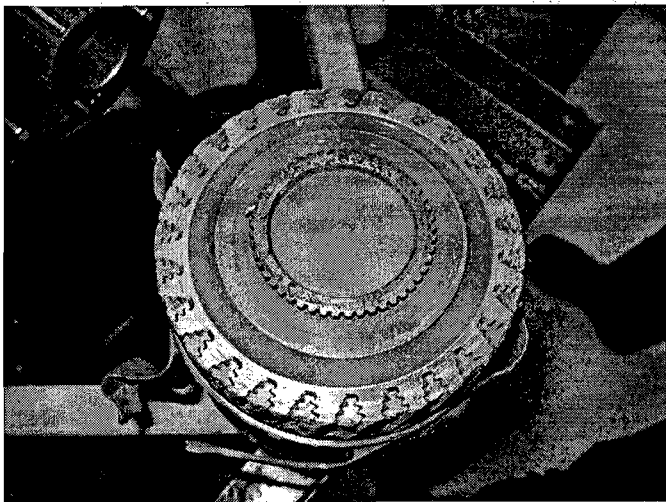
Figure 19: Power turbine wheel – blade shedding

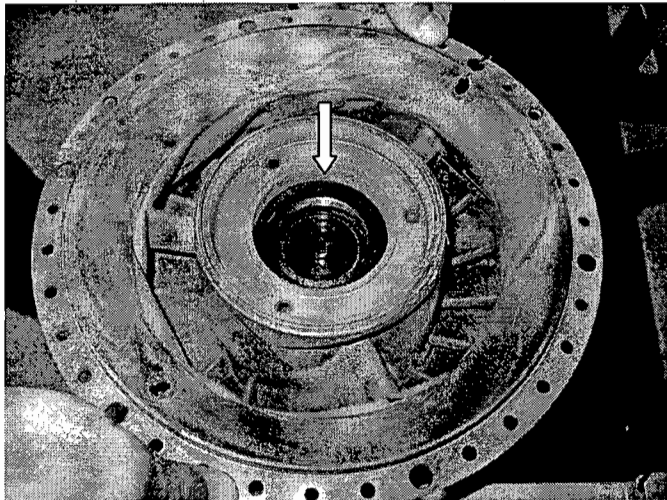
Figure 21: Labyrinth seal – damage

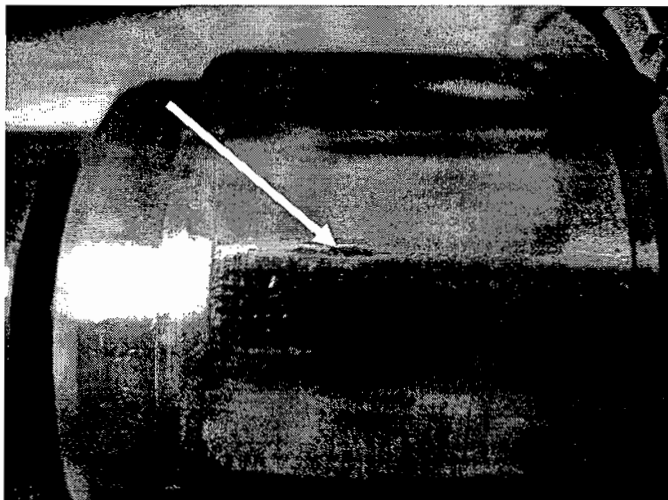
Figure 23: Slight mark on free wheel inner race

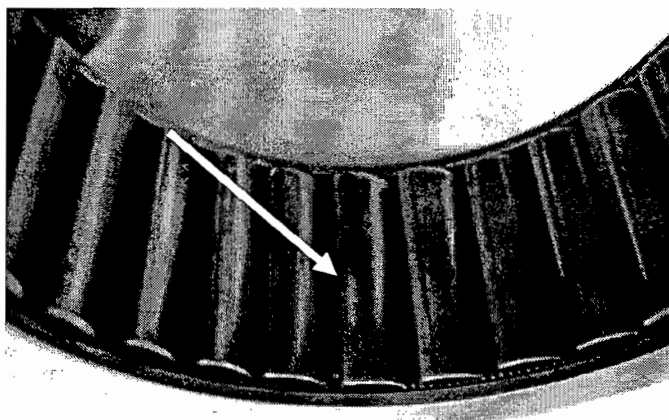
Figure 25: Slight mark on 2 free wheel clutch rollers
